101 FILE/DATE/TIME:	File # 5507 Date: 06-07-08 Time: 10:00 Completion time: 1:30.
102 CLIENT NAME:	John and Jane Doe.
103 LOCATION:	1234 Anywhere Street, Big Town, Ca. 92000.
104 BUYER'S AGENT:	Jim Smith.
105 LISTING AGENT:	Lisa Brown.

107 MAIN ENTRY:	Faces: Southeast.
108 STRUCTURE:	58 year old, 900 square ft., 1 story, single-family residence; as stated by the buyer's agent.
109 FOUNDATION:	Foundation types: raised foundation.

Inspection Report Exclusively For: John and Jane Doe

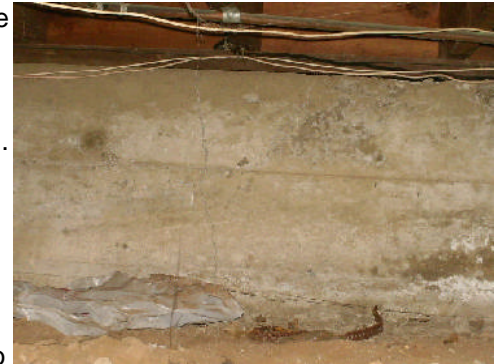
207 FOUNDATION: [NOTE] The concrete foundation had hairline and/or small cracks. This type of cracking is often a result of shrinkage of materials, settlement and/or seismic action and usually does not affect the strength of the foundation. [CR] There was a condition known as efflorescence on portions of the foundation walls. This is a salt deposit left when moisture in the foundation evaporates. It indicates that the foundation is experiencing wet and dry cycles. We recommend the exterior grading and drainage be improved to divert moisture away from the foundation.

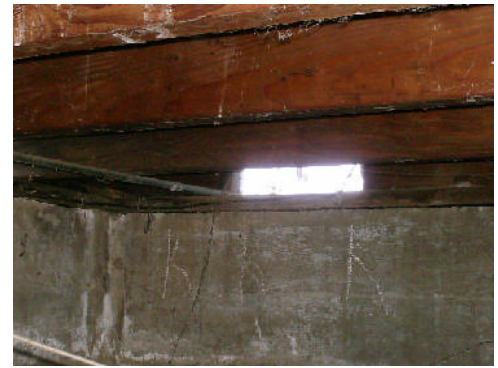
210 MUDSILL: [FE] There was evidence of conditions that require further evaluation by a pest control operator. We recommend further evaluation and corrections by a specialist in the appropriate trade.

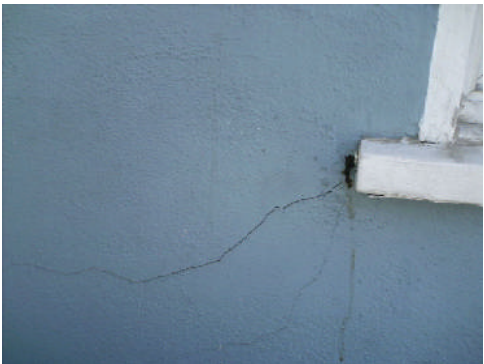
308 STUCCO SIDING:	<p>[CR] There were cracks/gaps in the stucco siding. These conditions are conducive to moisture intrusion/deterioration. We recommend further evaluation and corrections by a specialist in the appropriate trade. [NOTE] minor/common/ongoing maintenance. [RU] This building was built in an era before weep screens were installed at the bottom edge of the stucco siding, the stucco was extended into the soil. The stucco wicks water up out of the soil which causes it to deteriorate from being moist for prolonged periods. We recommend minimizing moisture around the building to help protect the stucco and the foundation from moisture damage. [CR] The stucco siding was damaged/deteriorated at some lower areas of the building. These conditions are conducive to moisture intrusion/deterioration. We recommend correcting the condition(s) noted. [NOTE] common.</p>

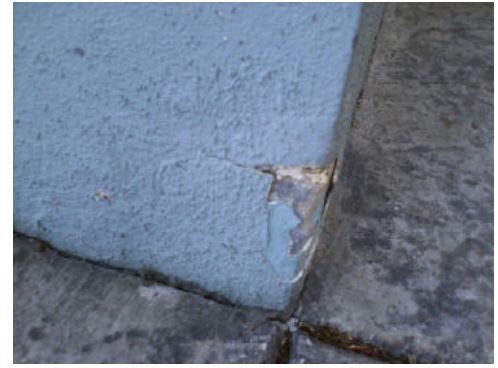
[NOTE] see comment in stucco siding section about lower area damage/deterioration.

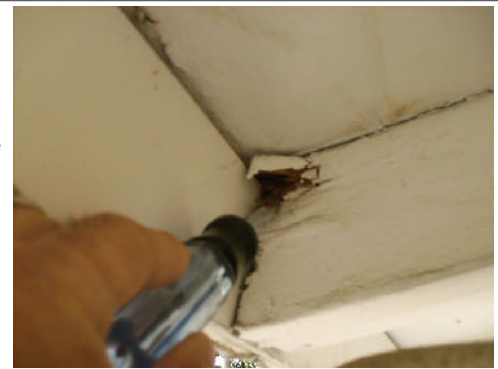
[FE] There were damaged/deteriorated trim materials noted at some eave/rafter tail areas. We recommend further evaluation and corrections by a specialist in the appropriate trade. [FE] There was evidence of conditions that require further evaluation by a pest control operator. We recommend further evaluation and corrections by a specialist in the appropriate trade.

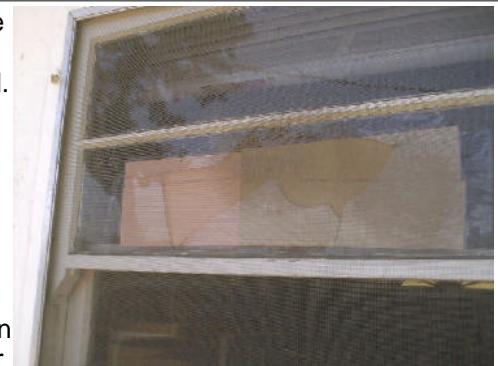
[CR] There was cracked/broken glass in one of the rear window(s) off garage area. We recommend correcting the condition(s) noted. [FE] Condensation/stains were noted between the glass panes in the right side bathroom area thermal window(s). We recommend further evaluation and corrections by a specialist in the appropriate trade. [NOTE] Double-pane windows/doors reduce noise and improve efficiency of heating/cooling systems. The space between the panes is factory sealed. If a seal fails, air from the environment enters the formerly sealed space. This condition causes condensation or fogging in the window(s), depending on the climatic conditions. We cannot assure the seal on each and every window, but we will attempt to note in the report the presence of visible condensation, fogging and/or moisture staining noted during the inspection. Due to climatic conditions, nature of the components and cleanliness of the glass, it is not possible to determine all failures. [CR] A number of the window screens were damaged. We recommend they be repaired or replaced as needed. [SC] There were no visible safety glass markings on the glass in the following locations: Garage area windows. We recommend the glass be identified as safety type or upgraded.

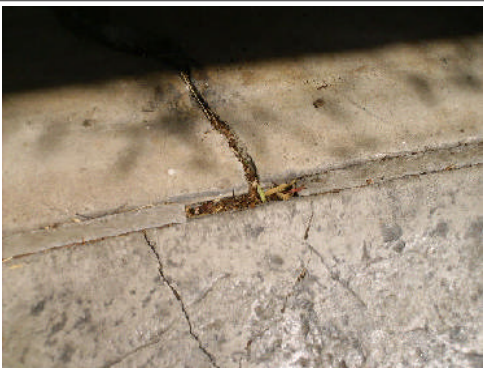
- 339 DRIVEWAY: [CR] There were cracks in the driveway. We recommend correcting this condition to prevent moisture intrusion into concealed spaces. [SC] Evidence of ponding water was noted on the driveway. This condition is a slip and fall hazard. We recommend correcting the condition(s) noted. [CR] There was a gap between the driveway and the garage floor. We recommend correcting this condition to prevent moisture intrusion into concealed spaces. [NOTE] minor at this time.

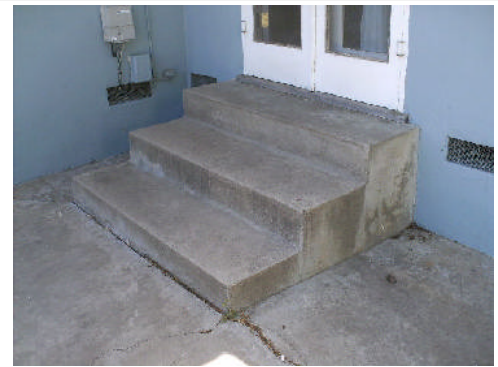
[SC] There were no handrail(s) at the rear stair system. We recommend correcting the condition(s) noted. [NOTE] The front area handrail(s) were serviceable.

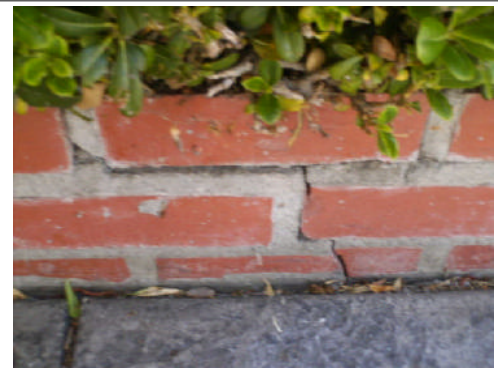
[CR] The decorative retaining/planter walls were damaged/cracked. We recommend correcting the condition(s) noted.

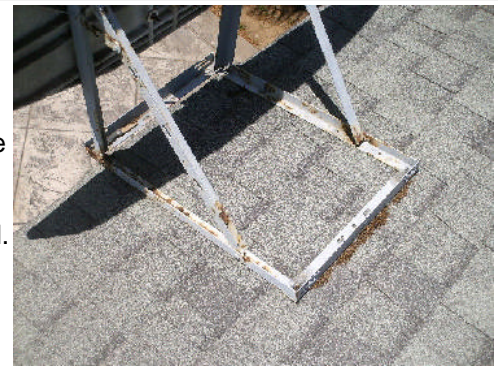
The visible areas of the roof appeared serviceable with signs of weathering and aging. Periodic inspection and maintenance is recommended. [CR] The installation of the basketball hoop feature is a breach of the materials and more likely will cause the roof to possibly leak in that area over time. We recommend correcting the condition(s) noted.

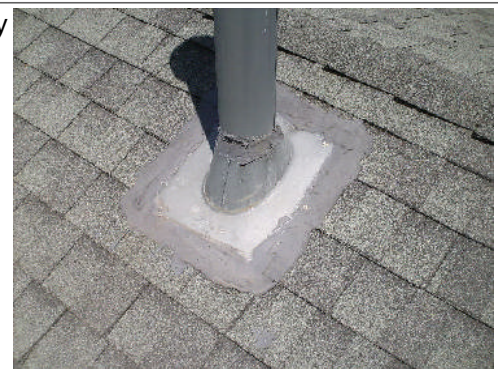
[FE] [CR] There was substandard/improperly installed flashings at the structure heating system flue feature area. We recommend further evaluation and corrections by a specialist in the appropriate trade. [NOTE] All other visible flashings appeared serviceable.

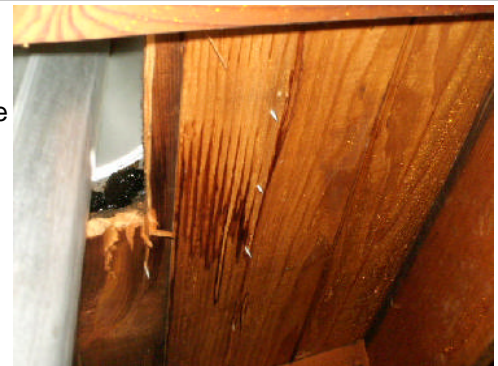
513 SHEATHING: [FE] Moisture stains were noted on the sheathing and framing in areas. The stains tested to be dry during the inspection. We recommend locating and repairing the source as well as any damaged materials.

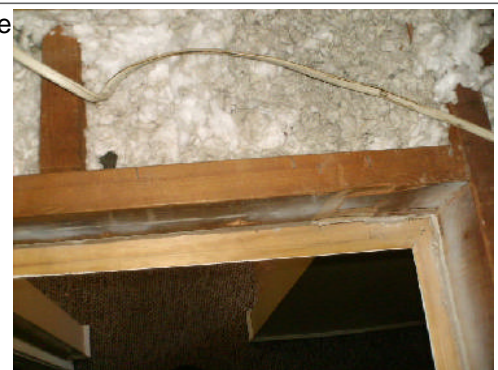
516 ELECT WIRING: [SC] The exposed wiring within six feet of the attic access opening was not protected from damage. We recommend correcting the condition(s) noted.

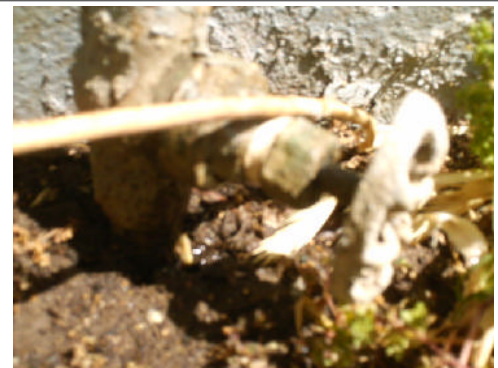
[CR] The main water shutoff valve was leaking. We recommend correcting the condition(s) noted. [RU] Recommend replacing the older gate valve with a newer ball valve system.

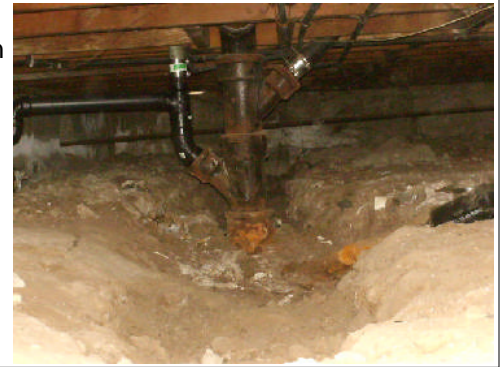
The visible waste piping appeared serviceable, [NOTE] There was corrosion on areas of the cast iron waste piping, no leakage noted. We recommend monitoring the condition(s) noted.

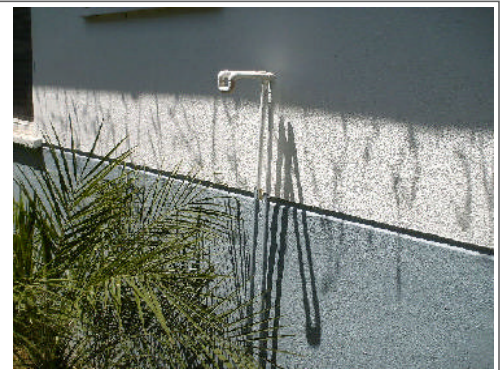
[NOTE] exterior right side visible piping appears to be plumbed for possible future water softening equipment.

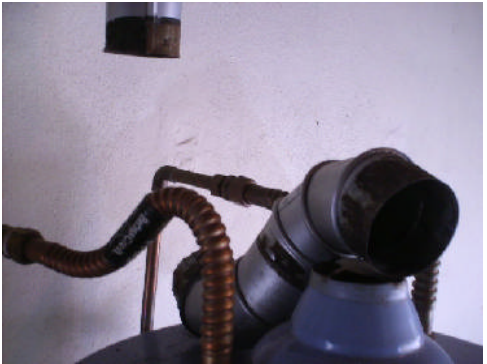
707 VENTING SYSTEM:	<p>[SC] The flue vent pipe was not secured as required. We recommend correcting the condition(s) noted.</p>

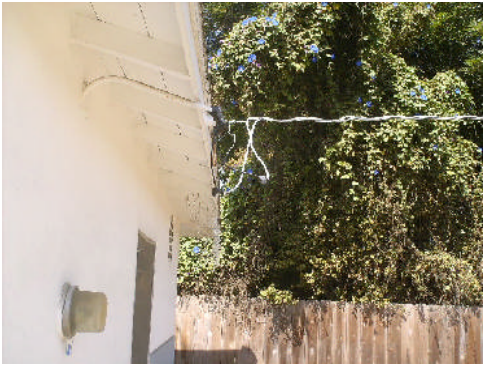
808 SERVICE WIRING:	<p>[SC] The overhead service entrance cables were hung too low over the rear area walkway/patio. This condition is a safety hazard. We recommend correcting the condition(s) noted.</p>

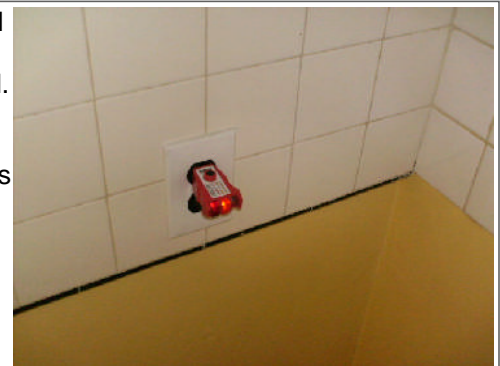
1101 WALLS/CEILING:	The visible areas of the walls and ceiling appeared serviceable, with signs of aging and wear.
1103 TILE FLOOR:	The visible areas of the tile floor appeared serviceable, with signs of aging and wear. [CR] Base boards were missing. We recommend correcting the condition(s) noted.
1107 INT DOORS:	[CR] The door(s) was removed. We recommend correcting the condition(s) noted.
1108 EXT DOORS:	The door(s) was serviceable.
1109 WINDOWS:	The accessible window(s) was serviceable.
1110 HEAT & COOL:	There was air movement from the air register(s)/grill(s)
1111 LIGHTS/FIXTURES:	The light(s) was serviceable.
1112 RECEPTACLES:	[SC] One accessible receptacles were found to have reversed polarity connections. We recommend correcting the condition(s) noted. [RU] The accessible receptacles were not GFCI protected. We recommend upgrading to provide GFCI protection for the receptacles for safety reasons.

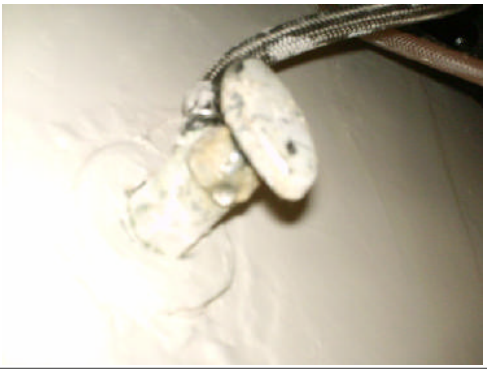
- 1114 SINK/PLUMBING: [CR] There was low water flow from the faucet. We recommend correcting the condition(s) noted. [CR] Active leaks were noted at the water supply piping/shutoff valves. We recommend correcting the condition(s) noted. [CR] Active leaks were noted at the waste pipes. We recommend correcting the condition(s) noted.

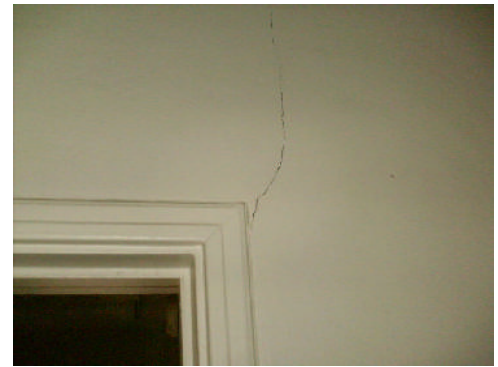
The visible areas of the walls and ceiling appeared serviceable, with signs of aging and wear. [NOTE] with some cracks noted.

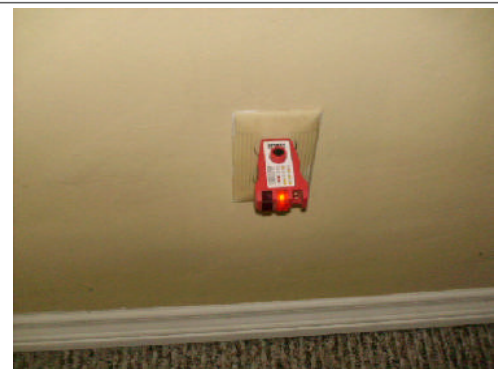
[SC] Some accessible three prong receptacles were found to have open ground connections. We recommend correcting the condition(s) noted. [SC] Some older two prong receptacles had loose wire connections. We recommend correcting the condition(s) noted.

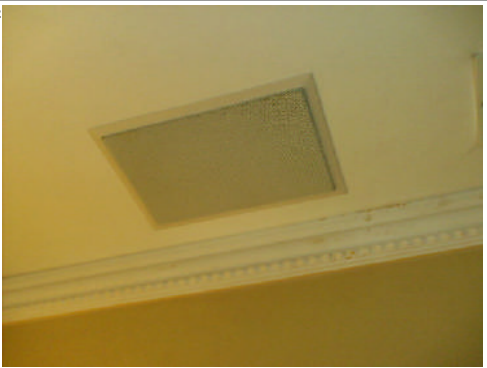
1422 CABINETS/TOPS:	The cabinet(s) were serviceable, with signs of aging/wear.
1428 COMMENTS:	<p>[FE] Speaker features are out of the scope of the inspection. [NOTE] We recommend the system(s) be demonstrated to the buyer(s).</p>

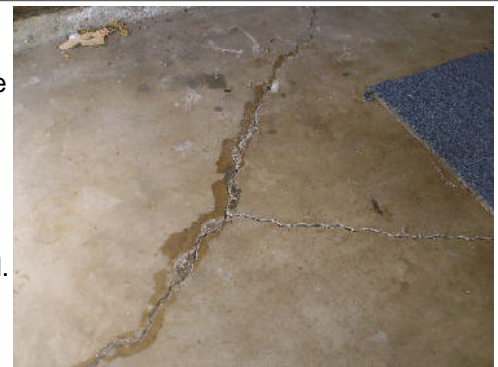
[FE] [CR] There were cracks and uneven sections in the garage floor. This condition indicates movement and is a trip hazard. We recommend further evaluation and corrections by a specialist in the appropriate trade. [SC] The carpet on the garage floor can trap spilled flammable liquids. This condition is a fire safety hazard. We recommend correcting the condition(s) noted.

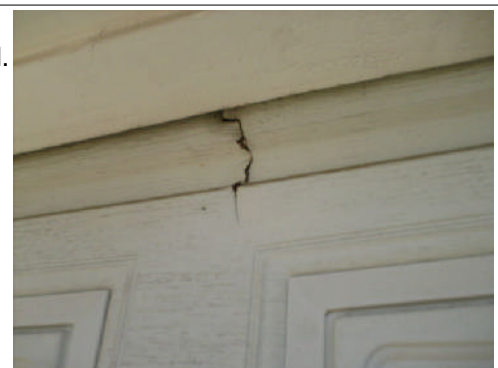
[CR] The car door(s) were damaged. We recommend correcting the condition(s) noted.
